RESTORATION OF THE HINDERER HOUSE, KUDETI, IBADAN

¹CORDELIA O. OSASONA AND ²OLUSEYI A. OLAGOKE

¹Department of Architecture, Obafemi Awolowo University, Ile-Ife

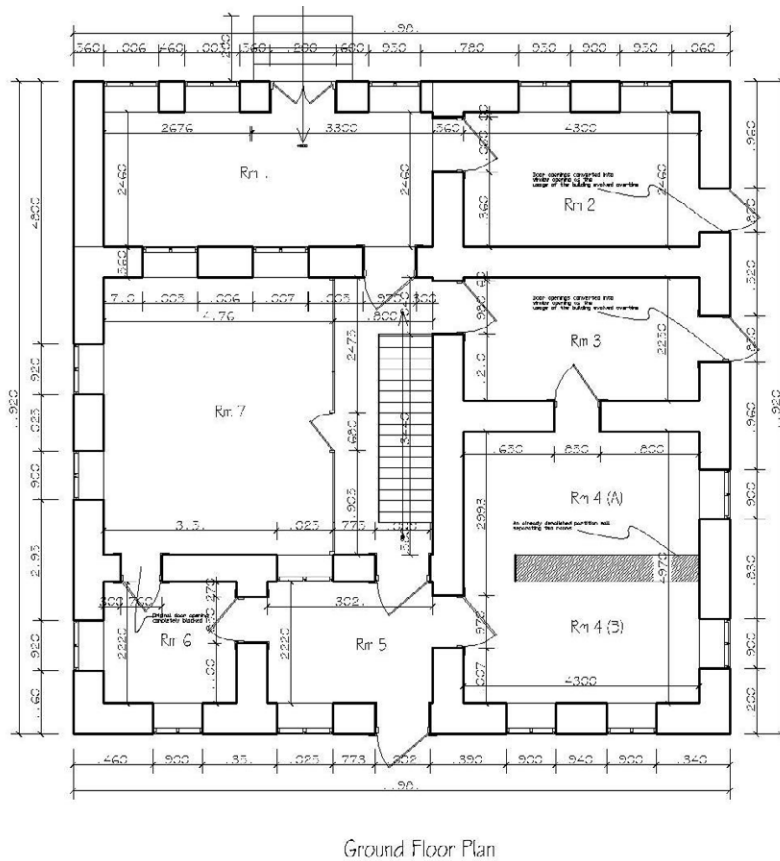
Fig. 1: Hinderer House – ground floor plan.

Even from Anna's "unprofessional" description, Hinderer House had been a worthy sight to behold in its heyday. On two levels, ample space was deployed to form an overall configuration of ten (10) rooms. On the ground floor, there were seven (7) rooms: the first, serving as an entrance lobby; another, substantially partitioned into two smaller areas, and a third, timber- partitioned off to create the stairwell.

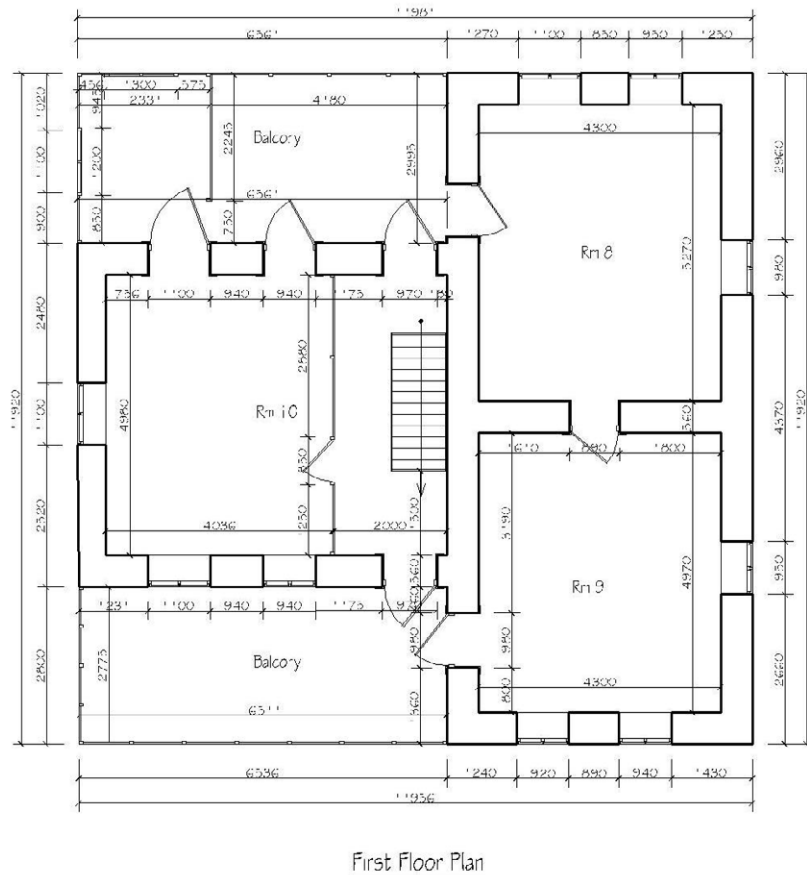
Fig. 2: Hinderer House – first floor plan.

On the upper floor, there were three (3) large rooms, the largest being similarly partitioned to continue the stairwell. At the front and at the back, there was a substantially deep veranda, making up the rest of the floor area. As with all British Colonial buildings of the time, the stairs were totally of timber. More interestingly, during the Hinderers' occupation of the building, a wooden ladder was the actual means of both ascent and descent. On retiring upstairs for the night, the ladder was retracted, and put against a wall on the first floor – only to be lowered, the following morning, for descent.

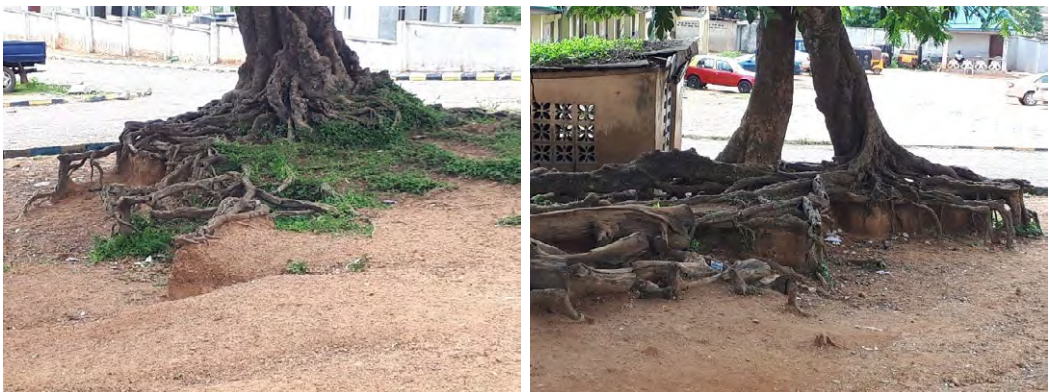
Plate 2 (a & b): Tree roots in the neighbourhood (2022).

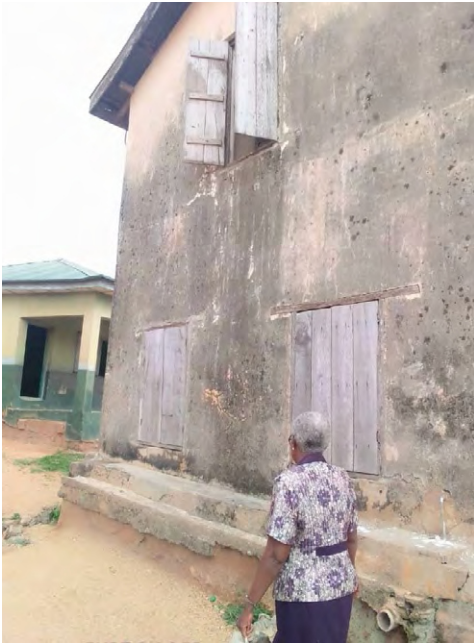
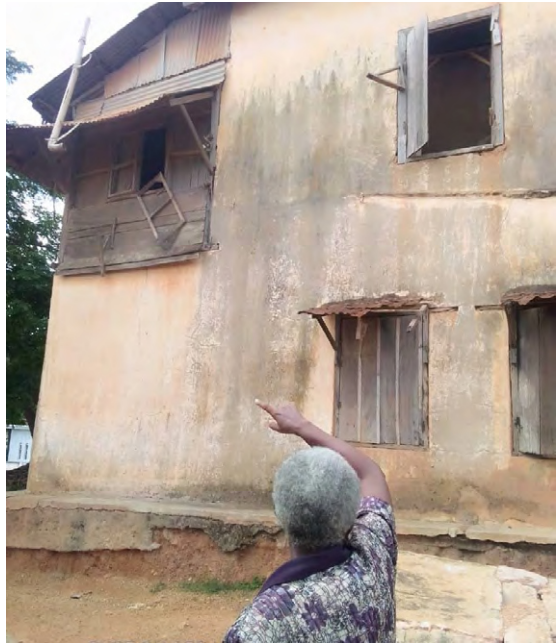
As at the time of taking possession of the Hinderer House site, the building was in a highly derelict condition. Obvious (and of great concern) was the extent of the soil erosion that had taken place in the immediate environment – and which had started to threaten the continued existence of the building. In many parts of the building, the plinth on which the whole structure rested was greatly undermined. (See the pictures below). Of similar structural concern were the deep cracks that were observed in some masonry walls – particularly external ones.

Plate 3 (a & b): Hinderer House – different wings, showing eroded building plinth & dilapidated windows.

The major focus in this regard was the plinth – the base of the building in touch with the ground. As earlier mentioned, this had suffered severe damage, over the years, and needed a drastic, long-term solution. It was decided to consolidate all foundation works around the building by creating another plinth, this time of 225mm (9in) sandcrete blocks and concrete, and to further reinforce the immediate building surroundings by a retaining wall, composed of two juxtaposed sandcrete blocks, filled with concrete. The pictures below indicate the process.

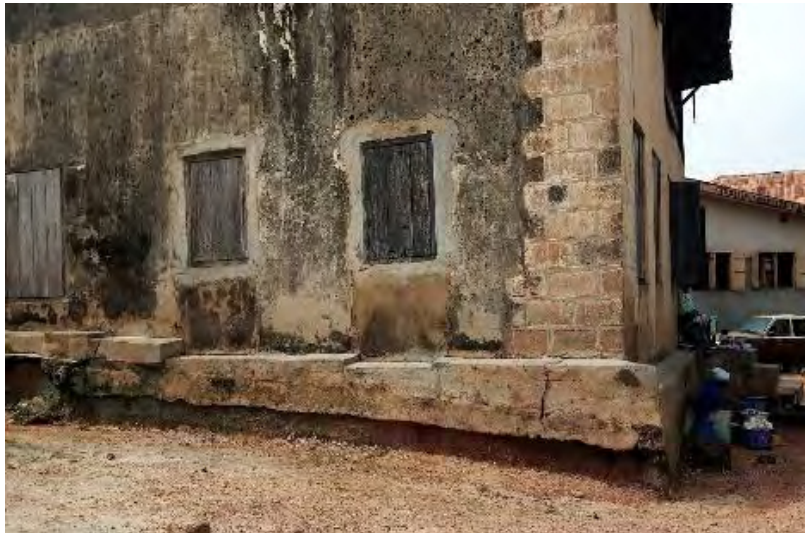
Compacted laterite had been used for the building's foundation and the pronounced plinth on which it rested. Similarly, all internal walls were of earth – except for the timber-panelling, adjacent to the staircase. All wall surfaces (and plinth) were plastered over with a sand-cement mix. A particular corner of the building had been done in dressed stone, and emphasised with pointing (imitating blockwork) on the wall-plaster.

Plate 4: Building corner done in stone, accentuated by pointing in cement-plaster. Notice the eroded plinth, as well.

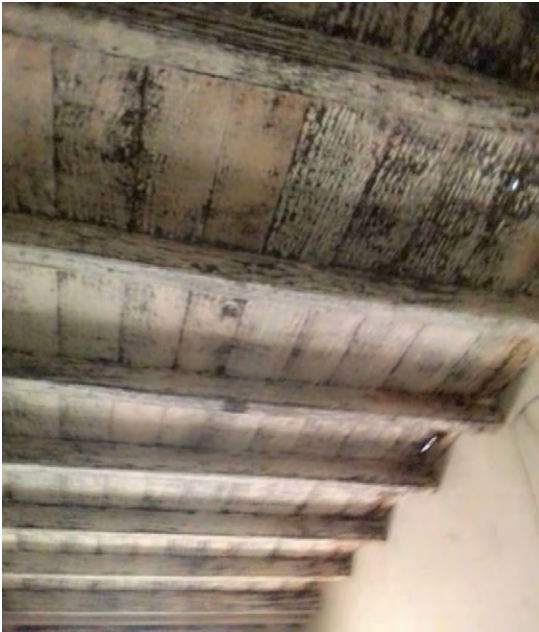
Plate 5: Timber-flooring from ground floor.

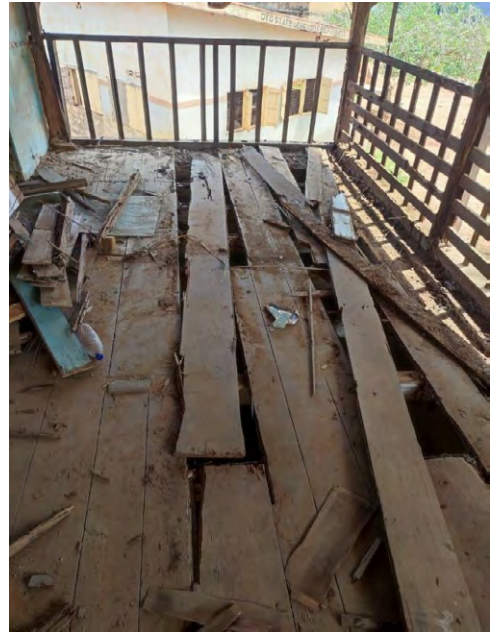
Plate 6: First floor veranda timber-flooring.

Timber-work that suffered the most damage, understandably, was with respect to floor-boarding in exposed areas (like the two verandas); the internal timber-panelled wall was in remarkably good condition. Other areas that could not be overlooked were with respect to missing (or defective) members of the overall roof structure, and also side-panelling and balustrading that enclosed the verandas.

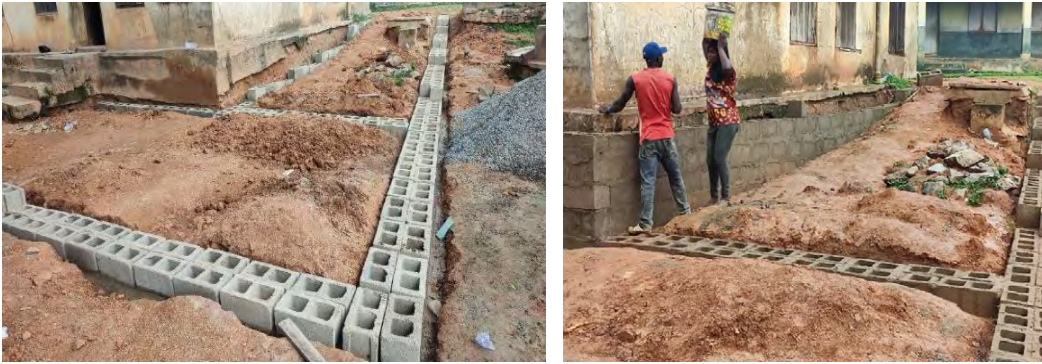
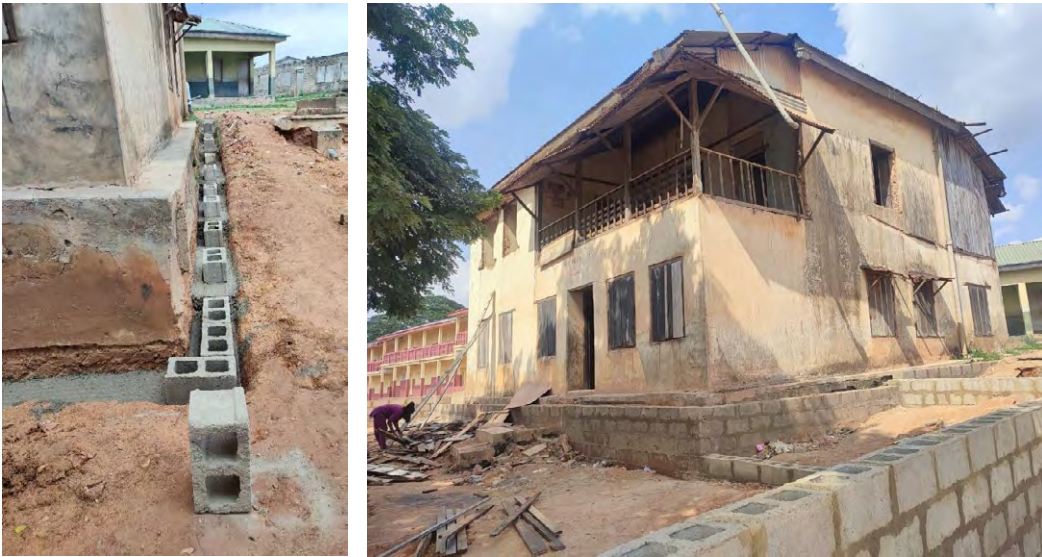
Plate 7 (a-d): External works – foundation consolidation: plinth/ retaining wall.

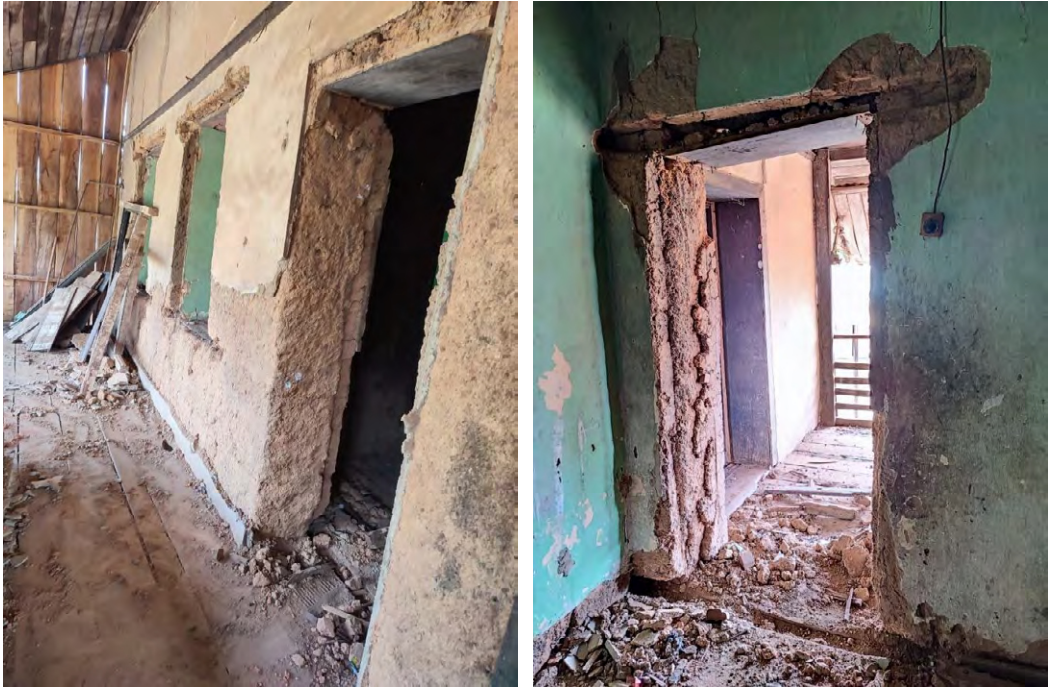
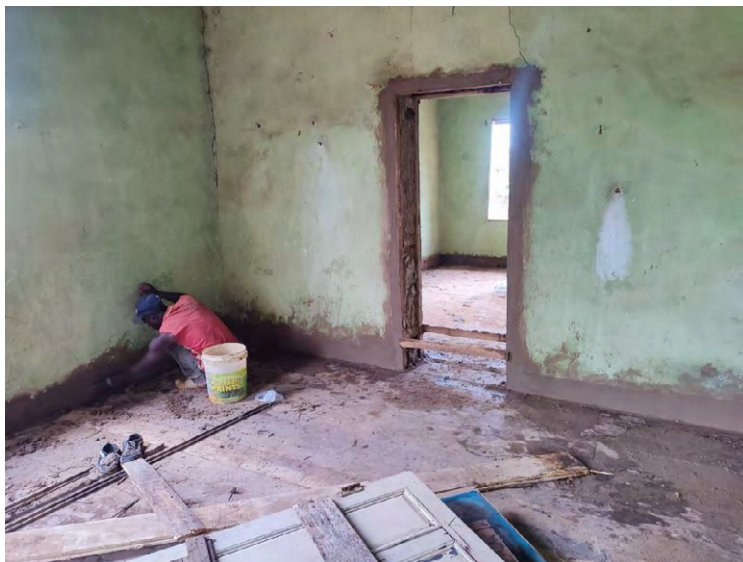
Plate 8 (a-c): Plaster-replacement around doorways and on walls, generally.

Other masonry repair-work undertaken includes the consolidation of wall-cracks; making up of defective plasterwork (on wall surfaces, particularly at the base), and pitted floor-screeding.

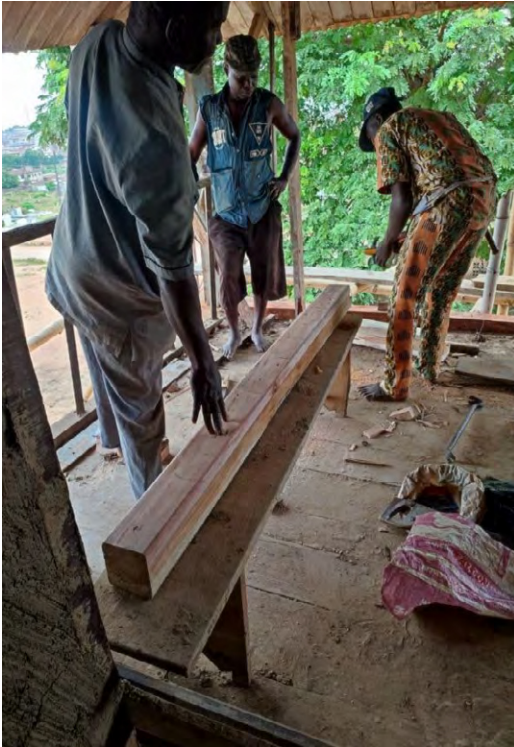
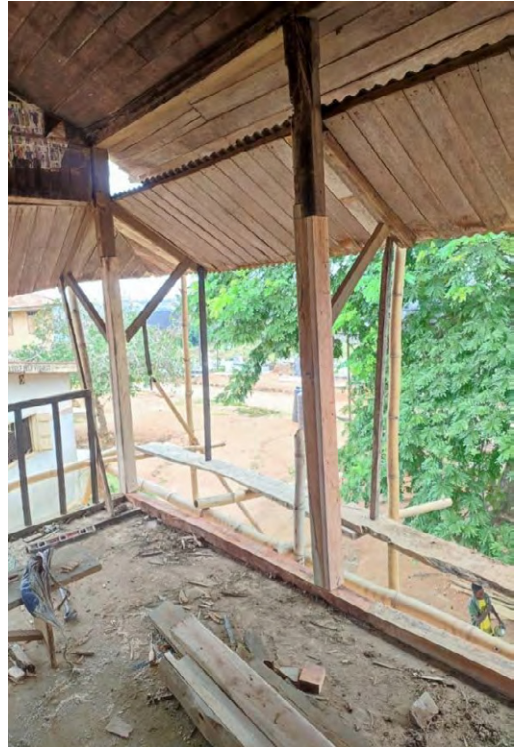
Plate 9 (a-b): Removal of defective timber posts & railings.

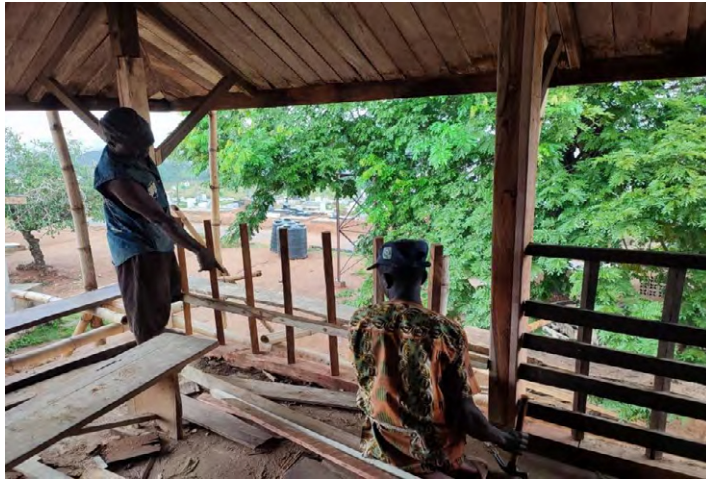
Plate 10: Replacement of defective timber posts and railings.

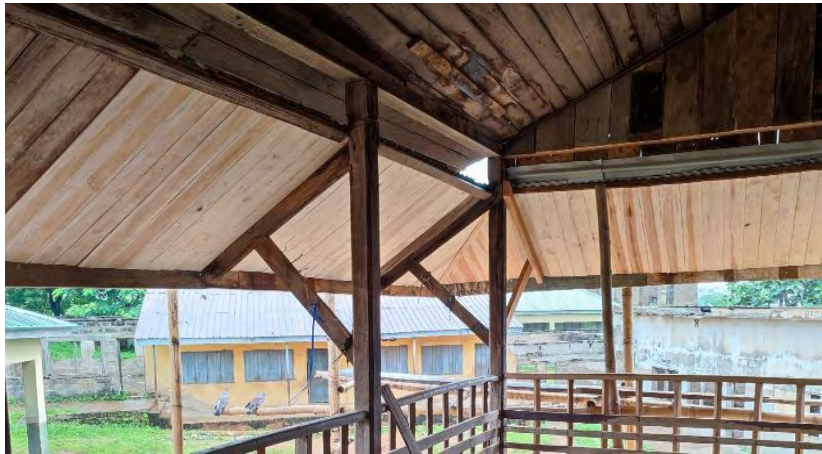
Plate 12: Veranda roof-extension ceiling repairs.

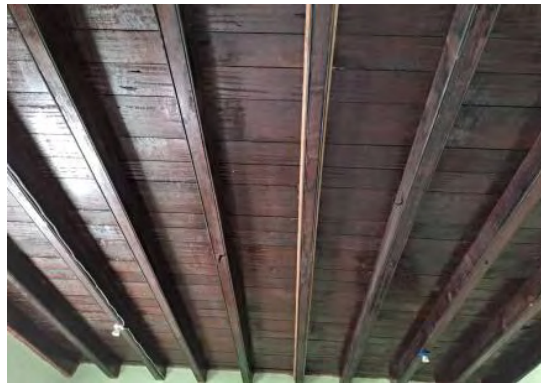
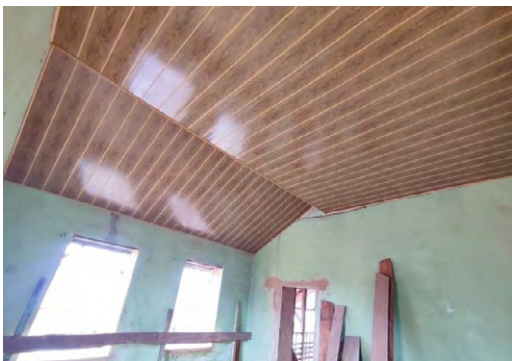
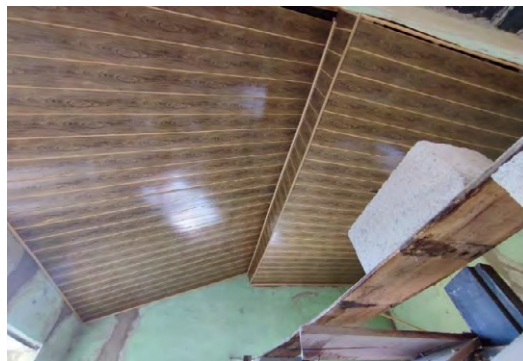
Plate 13 (a-c): Interior ceilings, after repairs. Note the use of PVC slats in b & c.

The period July to September coincided with the peak of the Rainy Season. Ordinarily, the setback with respect to masonry-work would have been anticipated and taken in stride. However, with respect to the extensive timber-work that needed to be done, the heavy rains posed a major challenge that was not anticipated: access to timber forests (to source the needed wood) was restricted. This greatly delayed availability of the timber to be used for truss- (and other structural timber-) replacement; also, timber for flooring, panelling and window-repairs. In consequence, the project went on till November – overshooting by two months. Even at that, some needed timber could still not be obtained, necessitating the use of synthetic (PVC) substitutes.

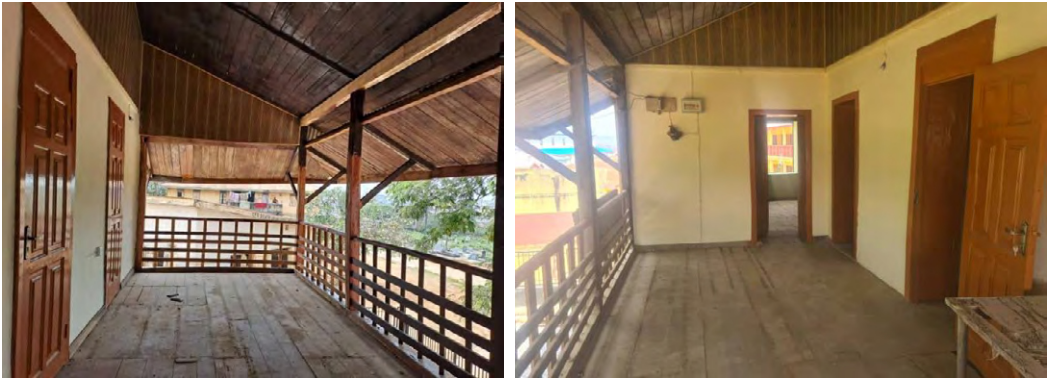
Plate 14 (a & b): Views of new-look verandas.

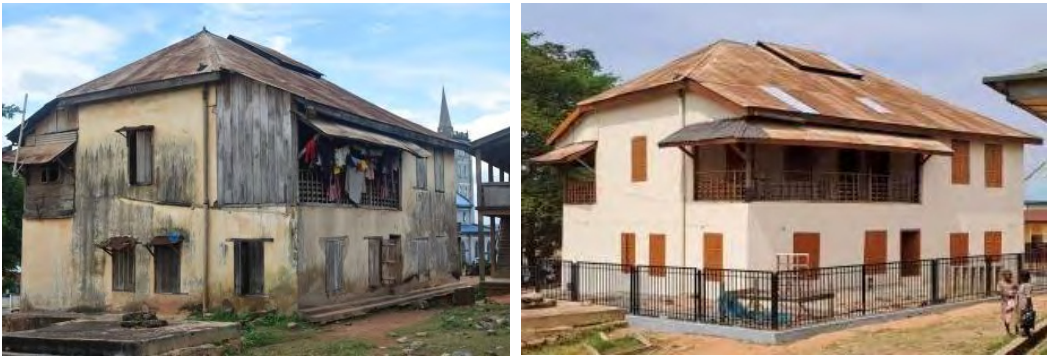
Plate 15 (a & b): Rear/ right flank views of Hinderer House – before & after.

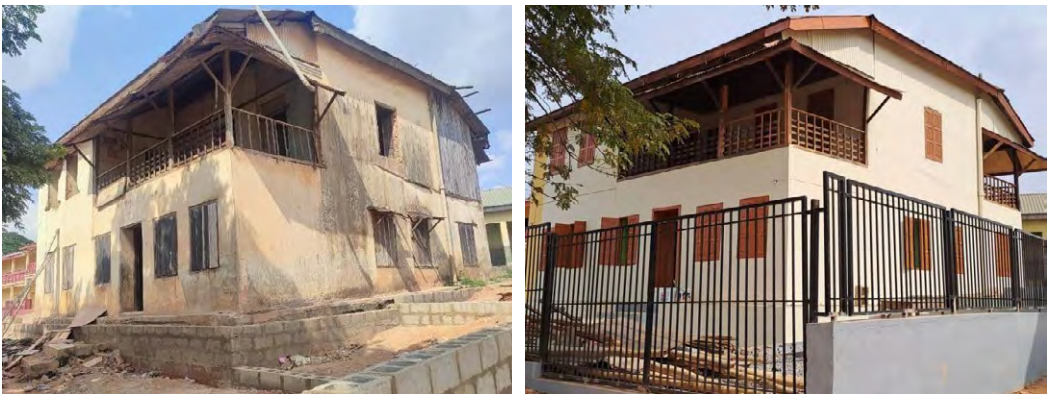
Plate 16 (a & b): Front/ right flank views of Hinderer House – before & after.

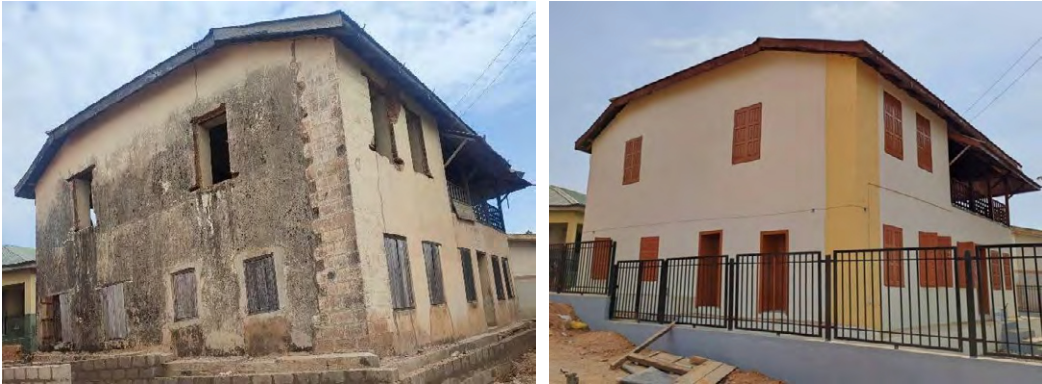
Plate 17 (a & b): Hinderer House; left flank/ approach façade. Note the restoration of two windows on the ground floor to doors.

As previously outlined, there were two options before the Team, in terms of the most appropriate approach to adopt: restitution or renewal. However, from preliminary surveys, it was obvious that the building was not actively in use by the St. David's Cathedral. Rather, only the Bible Society of Nigeria had recourse to a part of the ground floor, using it as its secretariat. It was also observed that a destitute had been given permission to use one of the rooms on the upper floor. With this background (and given limited available funds), it was decided that what the occasion called for was mere restitution to the building's as-built status. (As at the time of actually taking possession of the site, the only thing that was indicated as having undergone a change was the conversion of two of the doors that had previously opened out from the left-hand flank of the building, on the ground floor, into windows. So, apart from restoring these doors, repair works were the main operation to be engaged in on site).

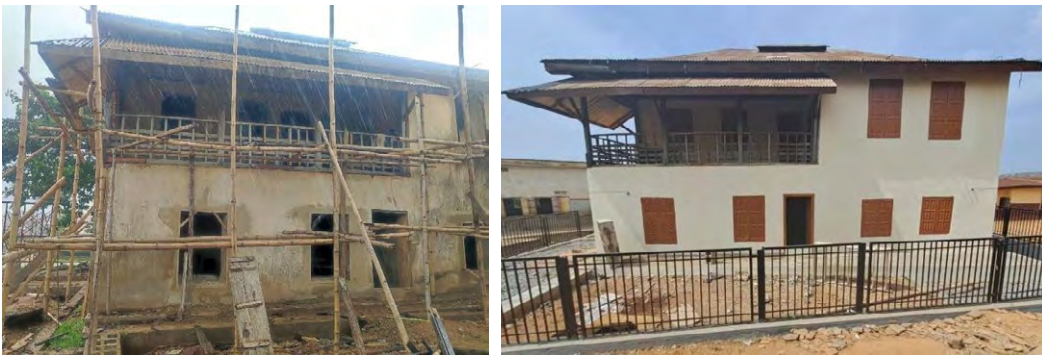
Plate 18 (a & b): Approach façade – before & after.
