# RIVERS OF ROADS AND ROADS OF RIVERS: THE Character and Impact of Two Great Floods in the Niger Delta Region of Nigeria

<sup>1</sup>CHRIS O. IKPORUKPO AND <sup>2</sup>ABIODUN AYOOLUWA AREOLA <sup>1,2</sup>Department of Geography, University of Ibadan, Ibadan, Nigeria Email: coikporukpo@yahoo.com

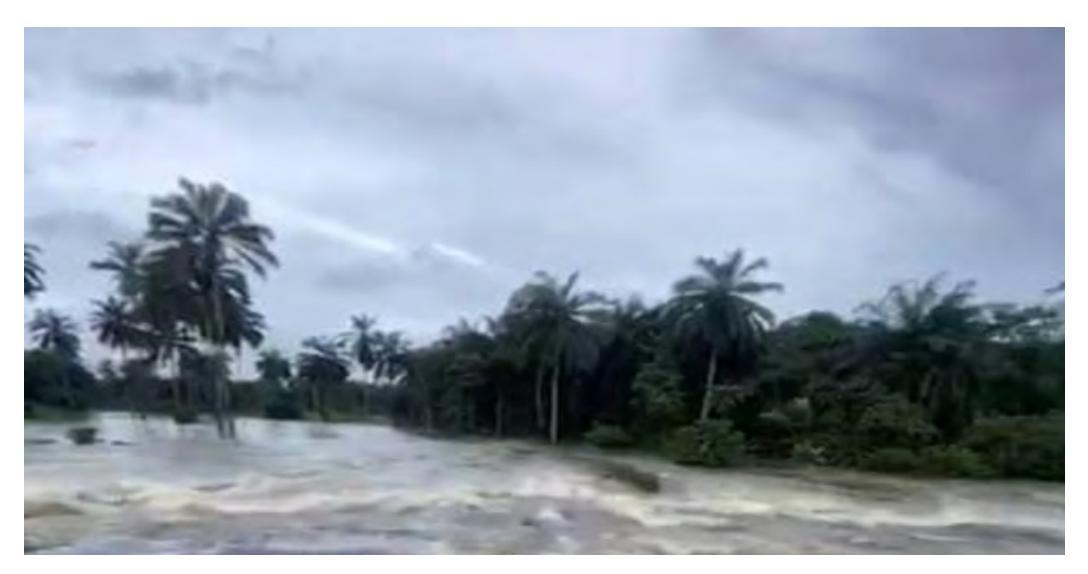
Figures 2 to 7 provide physical expressions of the floods. Figure 2 depicts forests in flood. Given the fact that these are very low areas and in many cases swamplands, all parts of the forests are usually flooded unlike the settlements and the inter-settlement roads where some parts may not be affected. In cases where the settlements are not located on levees, and have not been sand-filled, they are as vulnerable as the forests.

Figure 2: Flooded Forest along Yenagoa - Amassoma Road, Bayelsa State

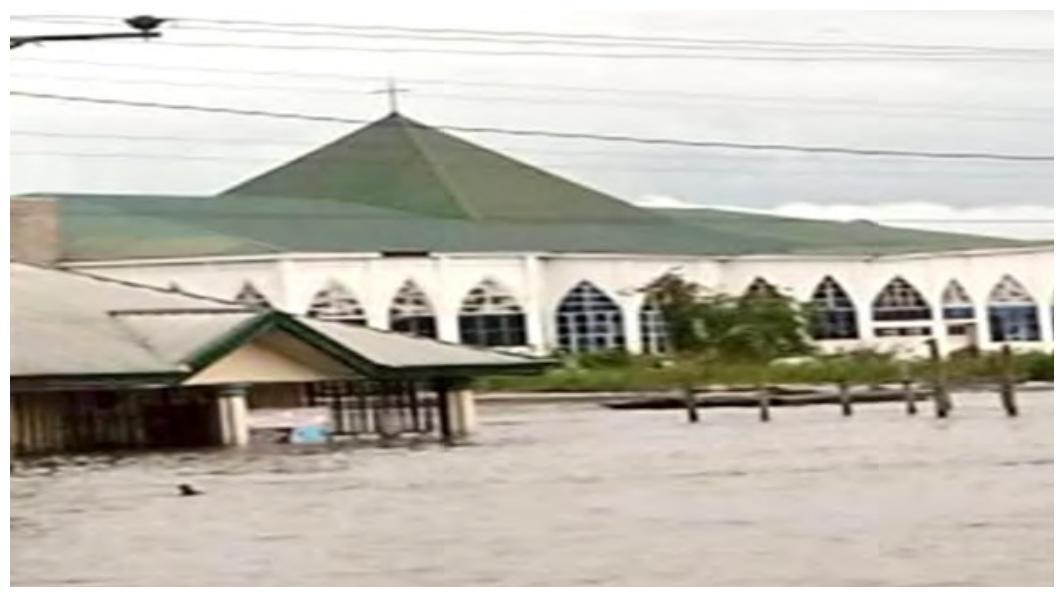
Figures 3 to 5 show different aspects of flooded settlements. In both 2012 and 2022 floods, typically not all parts of a given settlement were affected.

Figure 3: Flooded Bayelsa State Ecumenical Centre

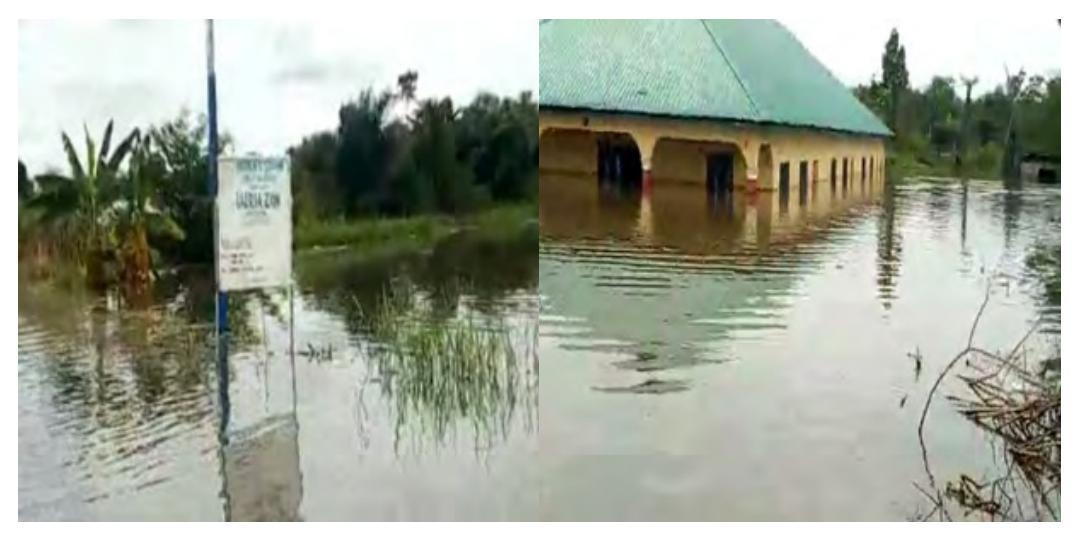
Figure 4: The Zion in Kpakiama, Delta State, Covered By Flood Water

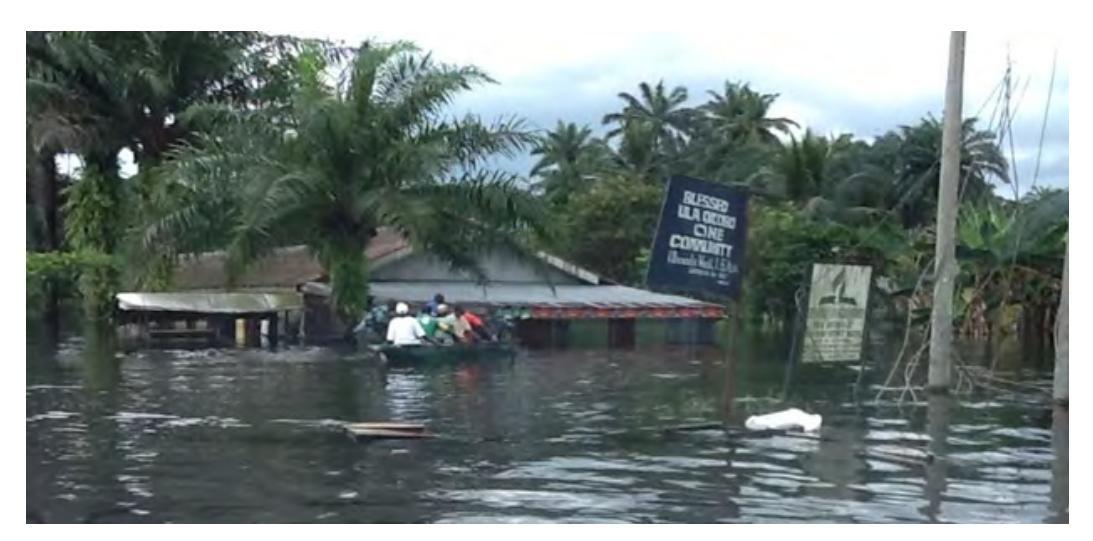
Figure 5: A Community in Ahoada West LGA, Okogboe, Rivers State in Flood

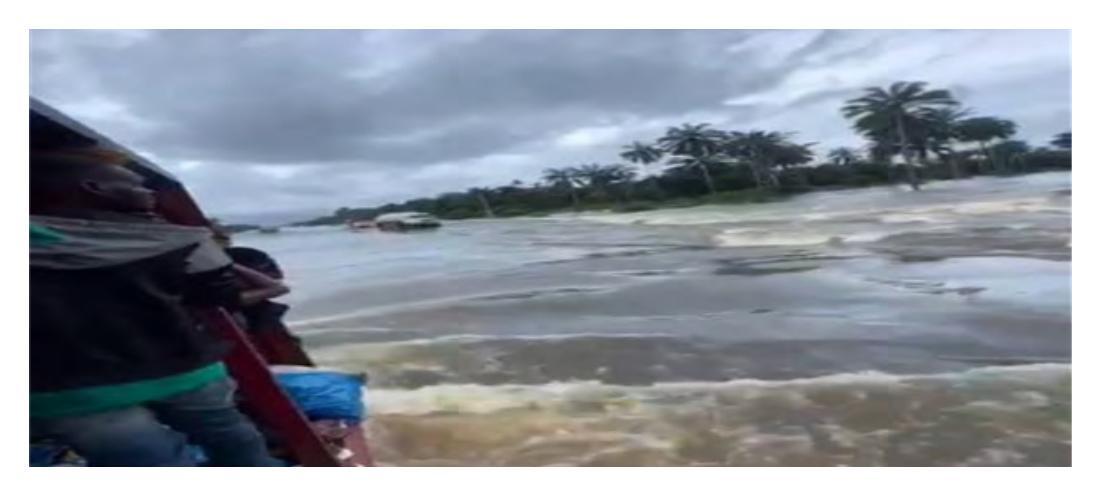
Figure 6: Extensive Flooding along the East-West Road in Rivers State

In both 2012 and 2022, several sections of the road were breached by the flood water. For instance, there were three major breaches along the East-West Road during the 2022 flood. These were Ume junction near Patani (Delta State), near Okogboe (Rivers State) and near Ahoada (Rivers State). In each of these locations, the flood water flowed across the road in a torrent. The result of such a torrent was that when the flooding was over, a deep gap was created which became a transportation challenge. This issue is examined in a later section.

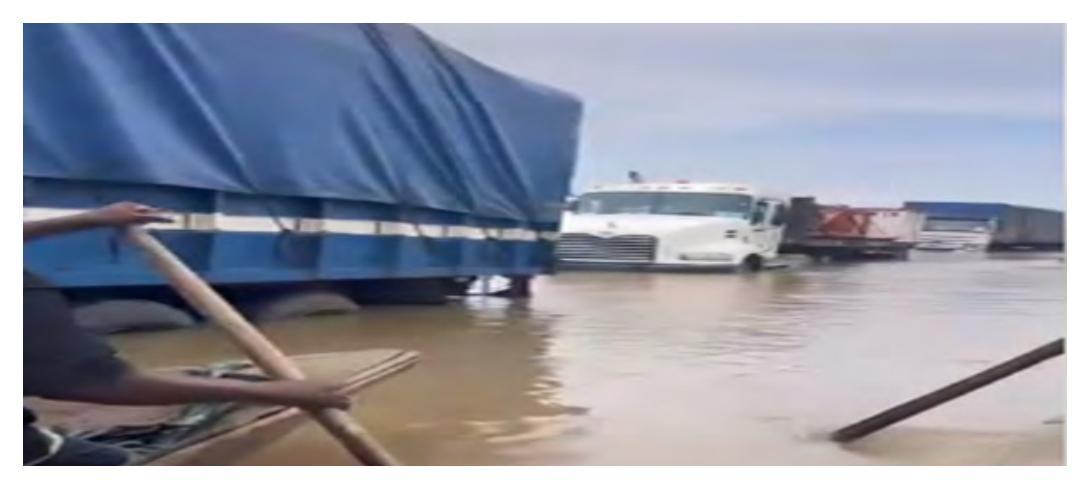
Figure 7: A Truck and a Canoe struggling for space on the Flooded East-West Road near Ahoada, Rivers State

Apart from the East-West Road, several major roads such as Ughelli-Asaba Road and the Ohoror-Bomadi Road were breached in several points. For instance, the Ughelli-Asaba Road was breached at seven points. These points included Ellu, Aradhe, Obetim, Obikwele, Iselegu, Ossisa, and near Nsukwa junction. The floods were so significant that many of the roads became rivers with canoes and other boats becoming the means of transportation in all stretches or large stretches of the roads (see Figures 6 & 7).

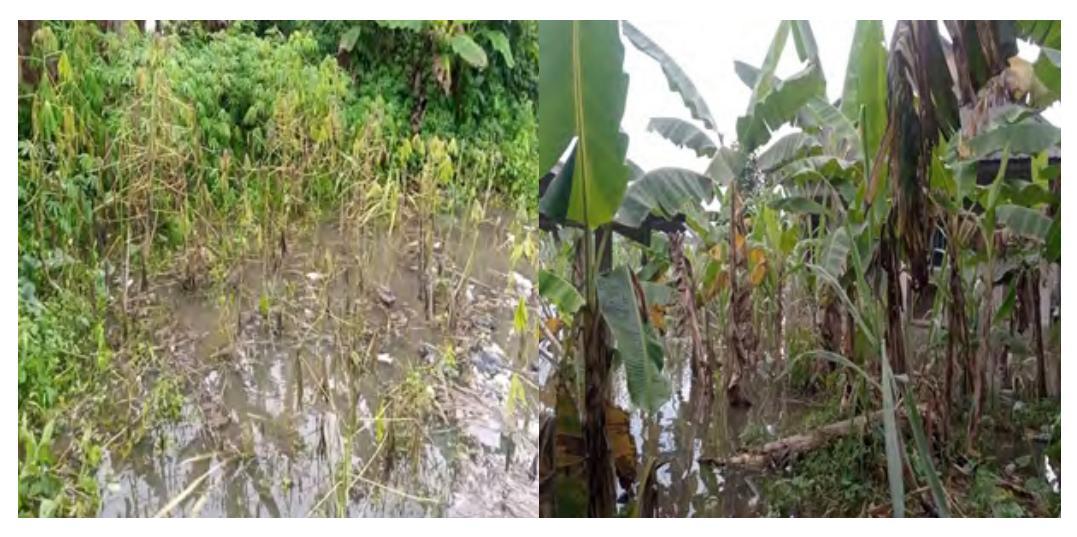
The implication of this impact on wildlife was that the ecosystem services they provided were lost. For instance, immediately after the 2012 flood, the number of animals killed by hunters and displayed for sale along the Yenagoa-Amassoma road, a common feature of the road, declined to zero (Ohimain, Izah & Otobotekere, 2014). This decline was characteristic of all other roads, such as the East-West Road and the Ughelli-Asaba Road. The harvesting of fuel wood and the burning of tree trunks for charcoal were also impeded; thus adversely affecting the energy-source available to a large proportion of the population. Agro-ecosystem services were also adversely affected. Figure 8 shows flooded farms. Cassava tubers readily rot.

Figure 8: Flooded Cassava And Plantain Farms Near Akenfa, Bayelsa State

Many farmers hurriedly harvested the tubers prematurely in order to avoid their rotting. The harvesting of immature crops such as cassava, plantain, yam, cocoyam, sweet potato and maize characterised these floods. Unfortunately, because the flood water rose fast, most farmers did not succeed in harvesting all the immature crops.

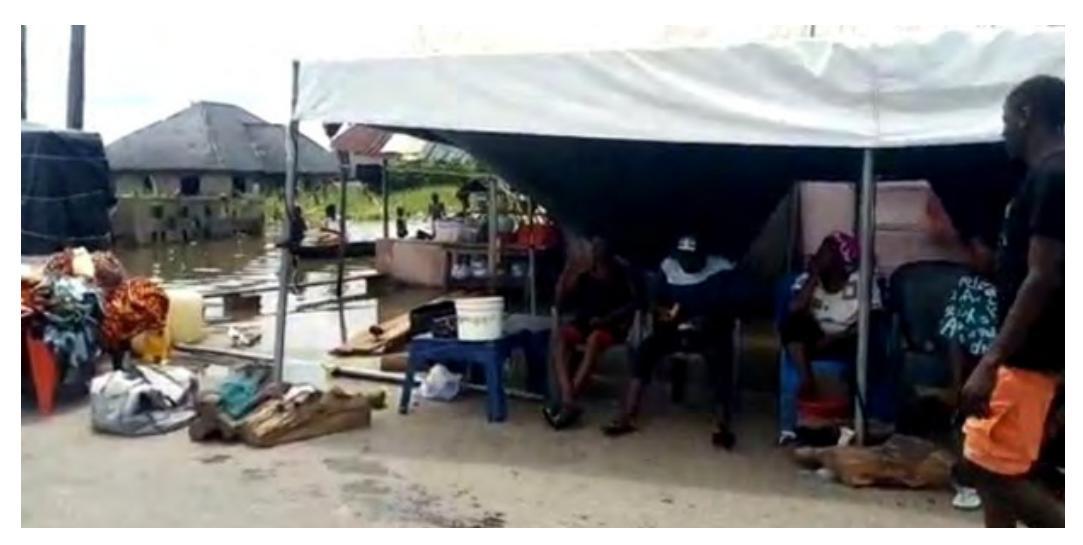
The floods were particularly overwhelming because, generally speaking, there was no flood-preparedness by individuals. Even the experiences during the 2012 flood did not guide people on mitigation in 2022. The general attitude was that the 2012 flood was unusual and therefore not likely to reoccur. Thus, even rudimentary flood-mitigation and coping strategies such as embankment using sandbags, and flood-water diversion through the use of dugout channels, were not commonly practised. There were also no relocation plans. In most cases, the floods took people unawares. The general pattern was such that it was when the flood-water started entering people's residences that there was a scramble to save valuable items. Such items that could not be readily moved were either placed in ceilings or left hanging from ceilings. The relocation decision was made in such a hurry that only few easily movable items, such as clothes, were removed. The unplanned nature also meant that many people did not readily know where to move to. Thus, any nearby area not flooded became a temporary abode. The major roads, which were generally on higher grounds were popular choices. Figure 9 shows an example of such stranded flooddisplaced individuals in Kpakiama (Delta State) occupying the road near their homes, imaging where to go to next.

**Figure 9:** Stranded Flood Victims in a Temporary Shelter on the Bomadi- Ohoror Road in Kpakiama, Delta State.

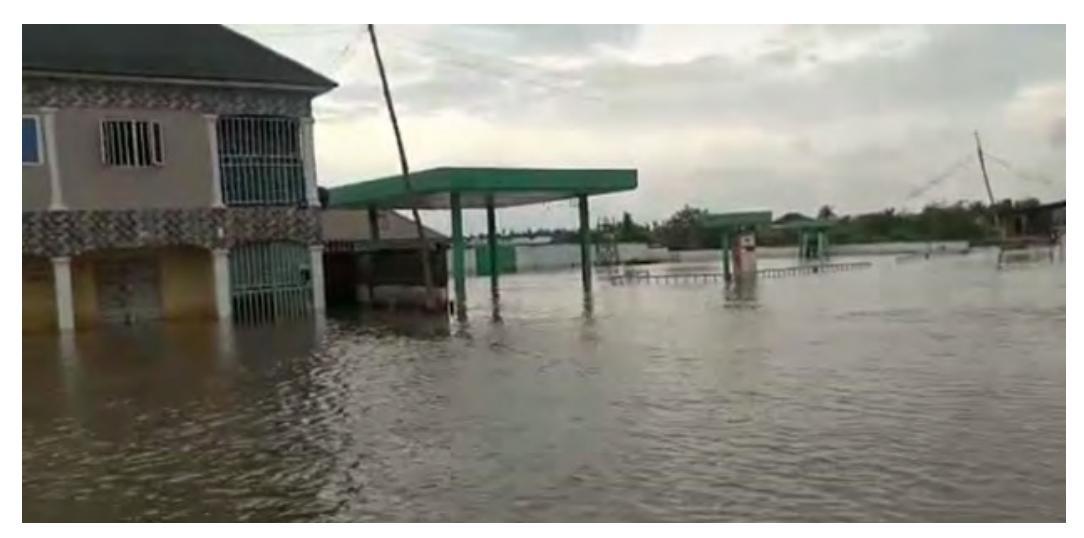
Figures 10 and 11 illustrate the impact the floods had on socio-economic facilities. For instance, the Niger Delta University, Wilberforce Island (Bayelsa State) and its Teaching Hospital at Okolobiri were shut for several weeks not only in 2012 but also in 2022.

Figure 10: Ido Petrol Station in Yenagoa, Bayelsa Sate, taken over by Flood Water

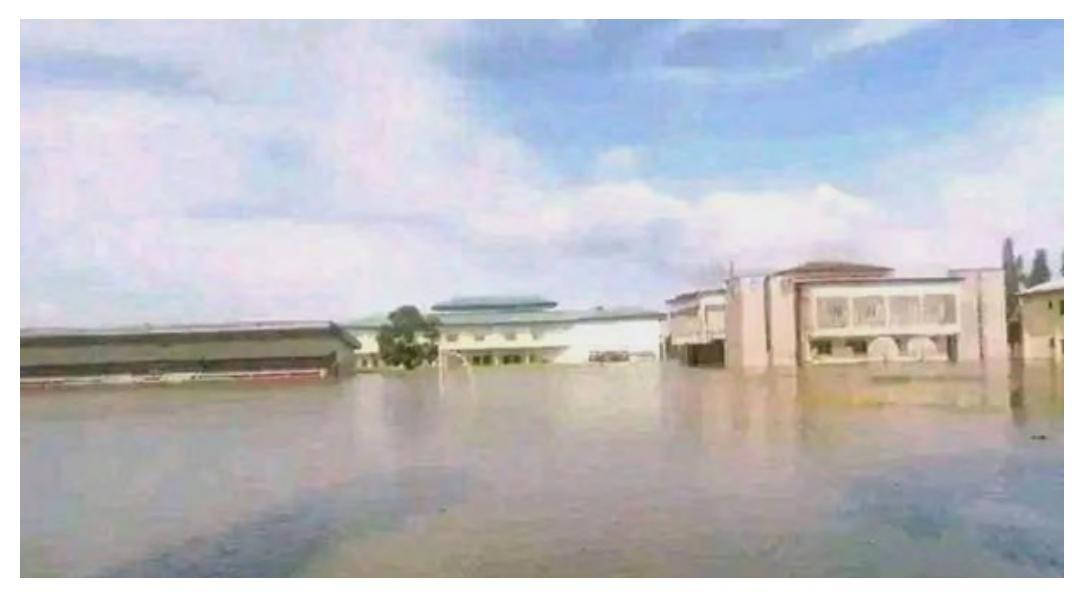
Figure 11: Niger Delta University Wilberforce Island, Bayelsa State in Flood

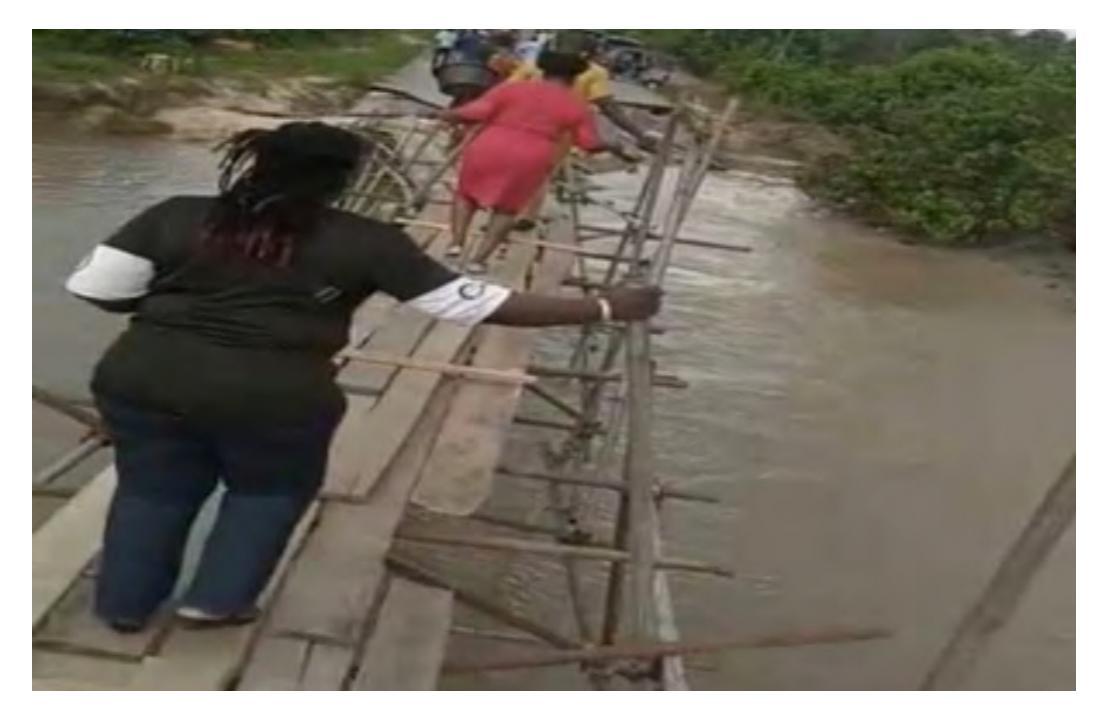
One of the most disruptive aspects of the floods was the impact on transportation systems, particularly the roads. Several major roads, such as the East-West road running across the region, Ughelli-Asaba road, Yenagoa-Amassoma Road and Yenagoa-Okolobiri Road were flooded. As illustrated earlier, many parts of these roads had flood-water deep enough to accommodate canoes/boats. Indeed, during the field studies of the 2022 flood, an observer, awed by the depth of flood water on the Yenagoa/Igbogene-Okolobiri road, exclaimed, "*the road is no longer motorable*! *It is only boatable*!" The floods were such that many parts of the region, particularly in Bayelsa State were cut-off from the rest of the country. Even intra-State movement was difficult. For instance, on the East-West Road, particularly between Mbiama and Ahoada (Rivers State), a combination of boats/canoes, lorries and trucks became the norm in road transportation. Individuals explored several ways of improving accessibility. Figure12, for example, shows the attempts to ensure that there was movement between Amassoma/Wilberforce Island and Yenagoa, the State capital. Table 3 indicates clearly the loss and damage consequent on the floods. Several facilities were damaged or destroyed, needing a lot of financial resources to rebuild.

Figure 12: A Makeshift Wooden Bridge Across a Breached Part of The Yenagoa- Amassoma Road, Bayelsa State.

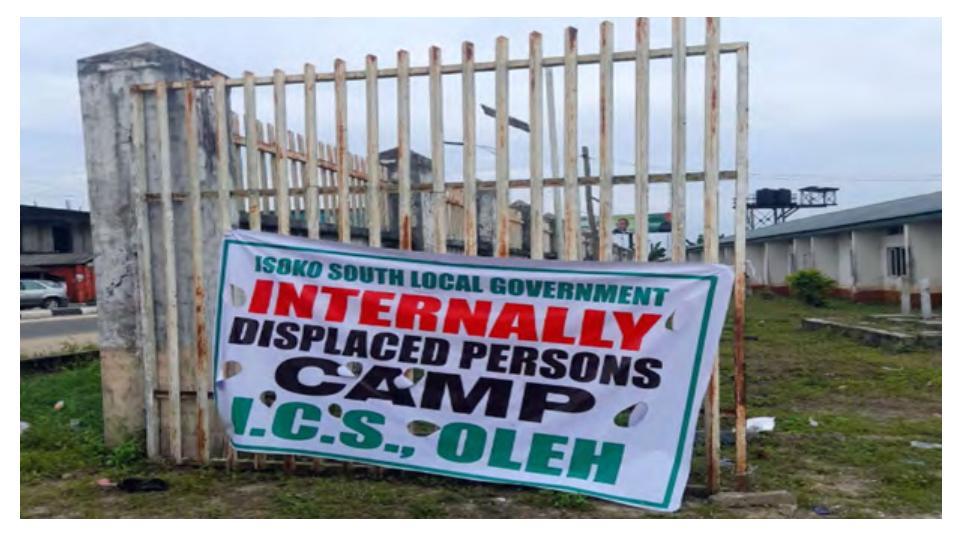
Figure 13: A Flood Victims' Camp in A Secondary School At Oleh, Delta State *Source:* Oviasuyi (2022)

Figure 13 shows a typical school serving as a flood victim camp. A woman displaced by the 2022 flood, accommodated in Ewu Grammar School, Ewu-Otor, Delta State camp lamented the poor state of the camp, thus:
